# FACILITY COMPLIANCE INSPECTION REPORT

## Division of Waste Management Solid Waste Section

**Date of Site Inspection:** 2/20/12, 1/31/12    **Date of Last Inspection:** 4/25/05

Burney Mountain Stump Dump – Phase One  
707 Burney Mountain Road  
Fairview (Fletcher)

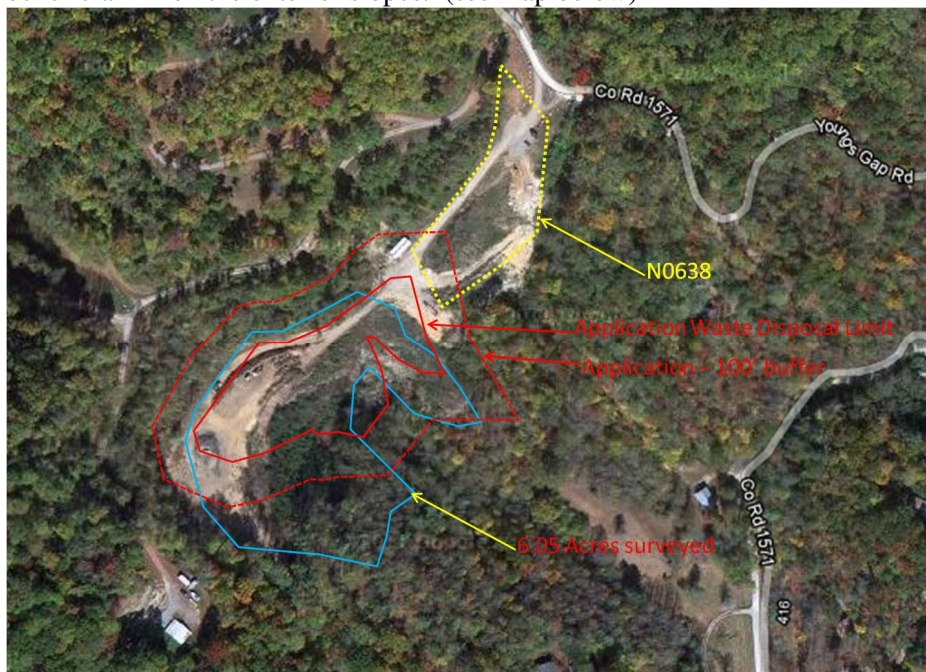
4. A portion of the NLCID landfill is on the property line/road. This portion (SReems) was land-filled during roadway expansion by DOT activities. The current active-fill slope is beneficial fill (SReems) with the Land Clearing debris located to the interior portion of the 2-acres. At this time, it is difficult to determine what portion of the fill activities were DOT managed (road-way expansion), land clearing, LCID mix, and beneficial fill on the exterior slopes. (see map below)

GIS map overlay of Phase Two site figures. Notified LCID N0638 shown above in yellow – approximate location.

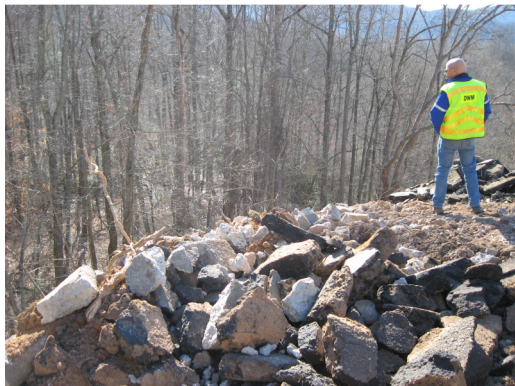
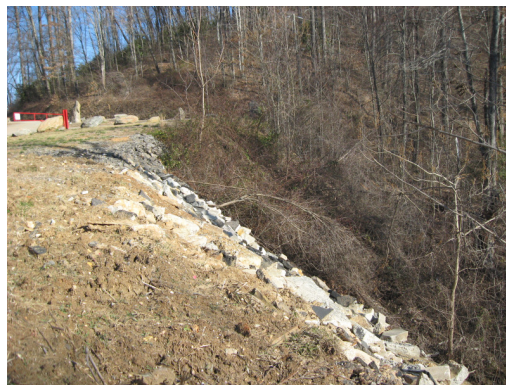
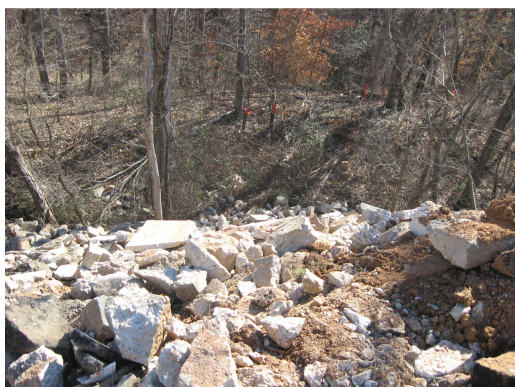
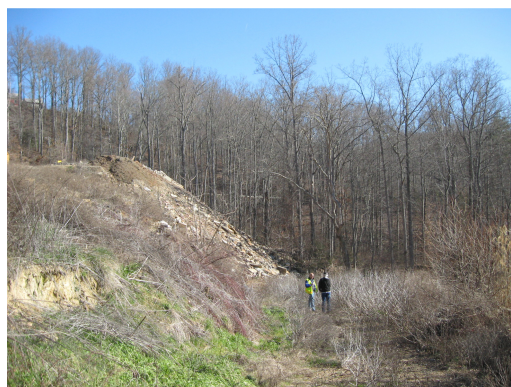
5. No land clearing materials were visible on the NLCID/Phase One landfill slopes – although yard waste (leaves) had recently been accepted for disposal at this location. The active disposal area slopes were constructed with rocks/concrete and were sloped to a degree that no vegetation was established and erosion control would be difficult to ensure.

Above photos were taken on 1/31/12 of the Phase One/N0638 landfill site.

- The exterior slope requires adequate soil cover (monthly) and the disposal area must managed such that 120 calendar days after completion of the disposal, the disposal area shall be covered with a minimum of one foot of suitable soil cover sloped to allow surface water runoff in a controlled manner. Adequate erosion control measures, structures, or devices shall be utilized to prevent silt from leaving the site and to prevent on site erosion [15A NCAC 13B .0566(4)(5)and(6)]; and

- Provision for ground cover sufficient to restrain erosion must be accomplished within 30 workings days or 120 calendar days upon completion of any phase of landfill development [15A NCAC 13B .0566(7)].

8. During the February 20, 2012 site meeting with Land Quality/Erosion Control representatives it was determined that the site required an updated site plan/erosion control permit for both Phase One and Phase Two activities. This plan should satisfy both the County requirements and the items noted above (#7).
